# Manhole Inspection Summary

Manhole # S31UU\_025MH

Insp Date: **5/3/07 11:05 AM**

**Location** Address: **210 29TH ST**

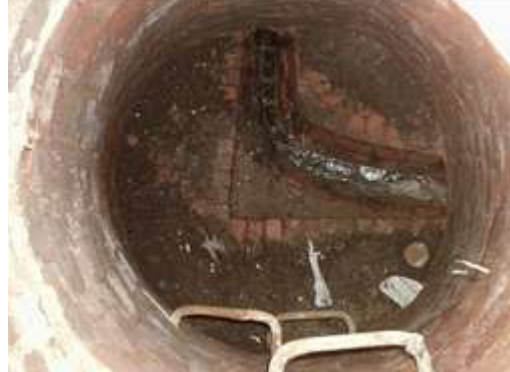
Top View

Corroded steps. Evidence of surcharge - Bench debris. Channel debris.

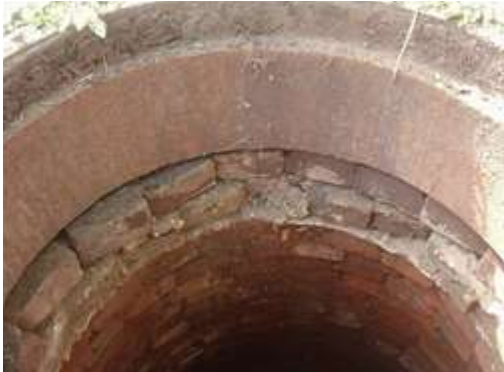
Defect

Frame leaks. Frame offset. Adjustment deterioration, loose brick and infiltration. Corbel deterioration and infiltration - other

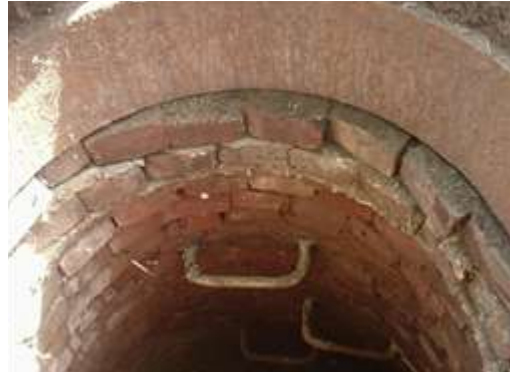
Defect

Frame leaks. Frame offset. Adjustment deterioration, loose brick and infiltration. Corbel deterioration and infiltration.

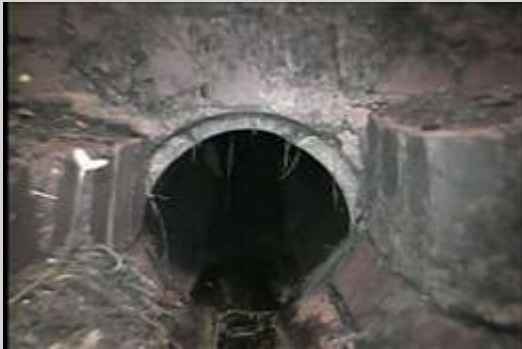
### 8 in. Circular Gravity Sewer Pipe Out @ 12 O'Clock

Channel deterioration and root intrusion.

Infiltration: **Evidence** Pipe Seal Cond: **Roots**

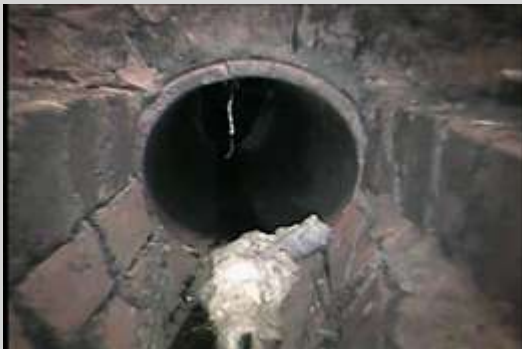
### 8 in. Circular Gravity Sewer Pipe In @ 3 O'Clock

Deposits: ☐ None ☐ Mud ☐ Sludge ☒ **Debris** ☐ Grease

Silt Depth: **0** (in.) Deposits Extent: **Light**

Infiltration: **None** Pipe Seal Cond: **Roots**
